# Manhole Inspection Summary

Manhole # S31K\_\_021MH

Insp Date: **12/29/08 8:24 AM**

**Location** Address: **522 Washington BD**

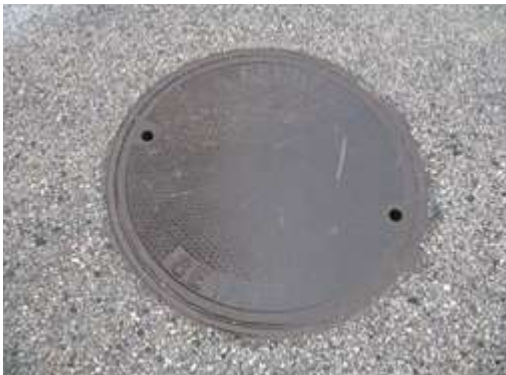
Misc

cover

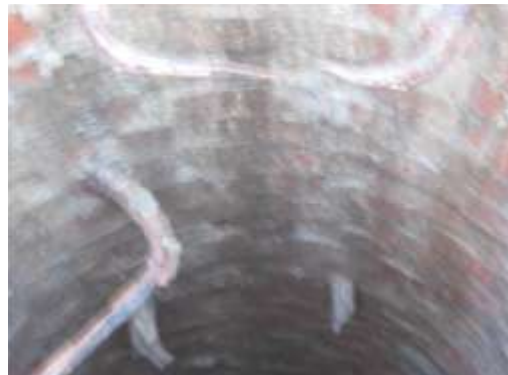
Defect 2

**Steps** Count: **7** Missing: **1** ☒ **Corroded**

steps corroded and missing

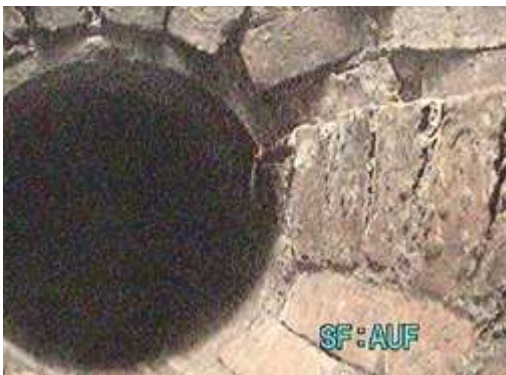
Defect 1

Condition: ☐ Sound ☐ Cracked ☐ Root Intrusion ☒ **Loose Brick** ☐ Deteriorated

barrel wall missing mortar

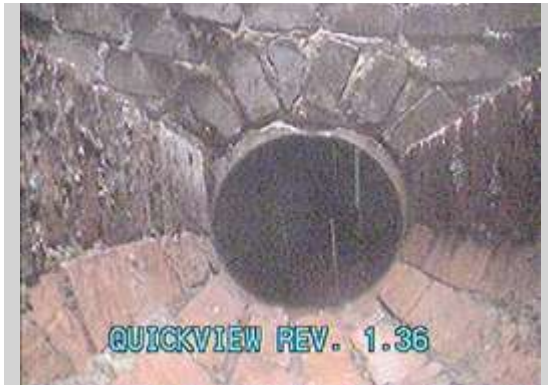
12 O'Clock Outflow

10 in. Circular Gravity Sewer  
Pipe Out @ 12 O'Clock

Pipe Height: **10.8** (in.) Rod and Bar (Angled)  
Pipe Material: **Clay** ☐ Pipe Lined  
Invert Depth: **12.38** (ft.) Flow Characteristics: **None**  
Deposits: ☒ None ☐ Mud ☐ Sludge ☐ Debris ☐ Grease  
Silt Depth: **0** (in.) Deposits Extent:  
Infiltration: **None** Pipe Seal Cond: **Sound**

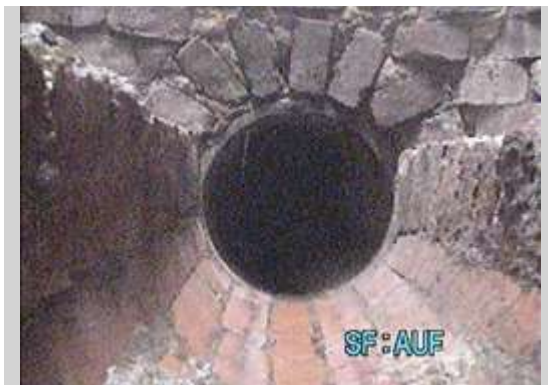
6 O'Clock Inflow

10 in. Circular Gravity Sewer  
Pipe In @ 6 O'Clock

Pipe Height: **10.8** (in.) Rod and Bar (Angled)  
Pipe Material: **Clay** ☐ Pipe Lined  
Invert Depth: **12.15** (ft.) Flow Characteristics: **None**  
Deposits: ☒ None ☐ Mud ☐ Sludge ☐ Debris ☐ Grease  
Silt Depth: **0** (in.) Deposits Extent:  
Infiltration: **None** Pipe Seal Cond: **Sound**
